Monthly Oversight Report 69
44728 AES [46526 RAC]
ACS NPL Site
Griffith, Indiana
September 2, 2006 – September 29, 2006

Subject: Monthly Oversight Summary Report
No. 69 for September 2006

Monthly Oversight Summary Report No. 69
ACS Superfund Site
TO 057, 44728.238 (AES) [WA57, 46526.238 (RAC)]

Reporting Period: Month of September (September 2 through September 29, 2006)

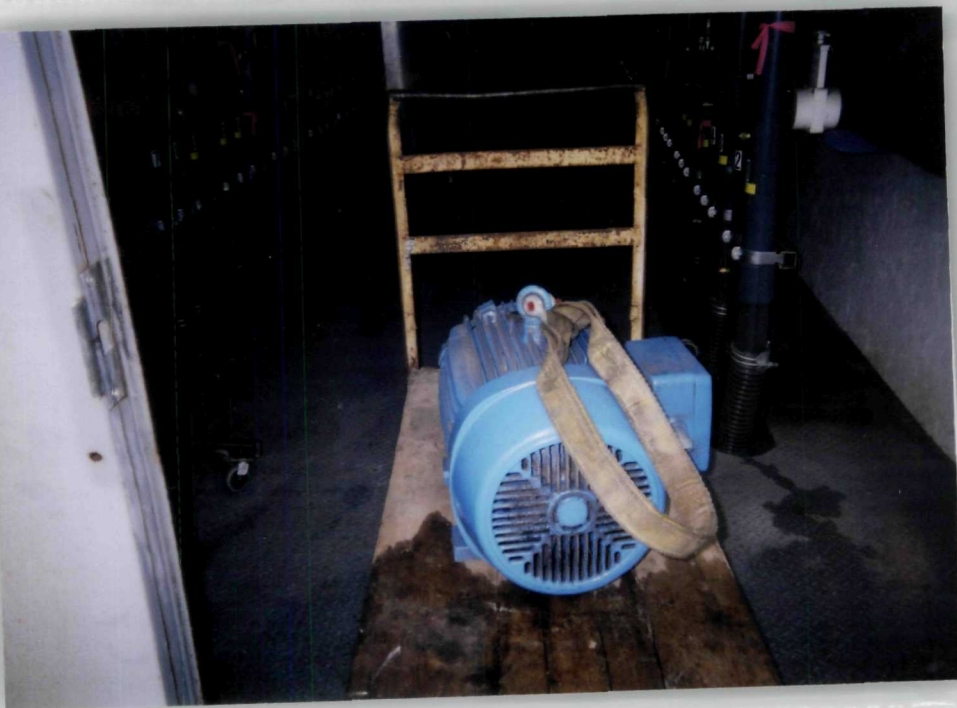
Site: American Chemical Service, Inc.
Proj. #: 44728 AES [46526 RAC]
Roll: 92 Photo #2
Date: 9-11-06 Time: 1122
Photographer: Larry Campbell
Description: Photo facing west at SBPA ISVE blower shed showing non-functioning blower motor prior to being shipped out for repair or replacement.

- MWH reported that the SBPA blower motor stopped working during the weekend of September 9 and 10. MWH ordered a new motor and installed it on September 18. Operation of the SBPA ISVE system was resumed on September 18.

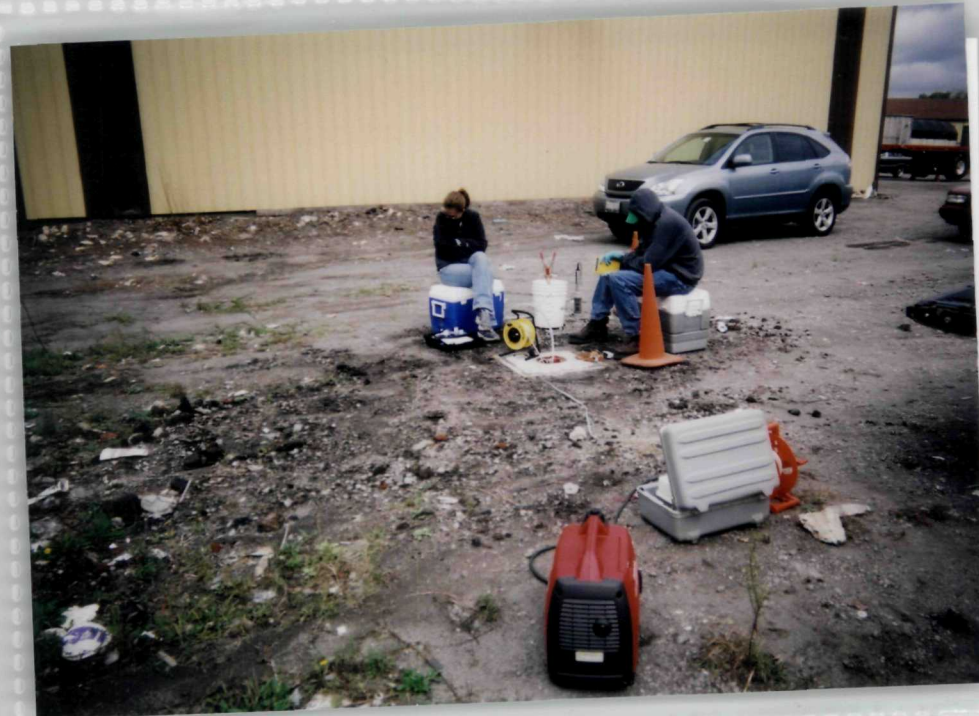
Site: American Chemical Service, Inc.
Proj. #: 44728 AES [46526 RAC]
Roll: 92 Photo #3
Date: 9-19-06 Time: 1030
Photographer: Larry Campbell
Description: Photo facing northwest showing Leslie and Tim of MWH purging water from MW58 in preparation for the initial sampling of this well.

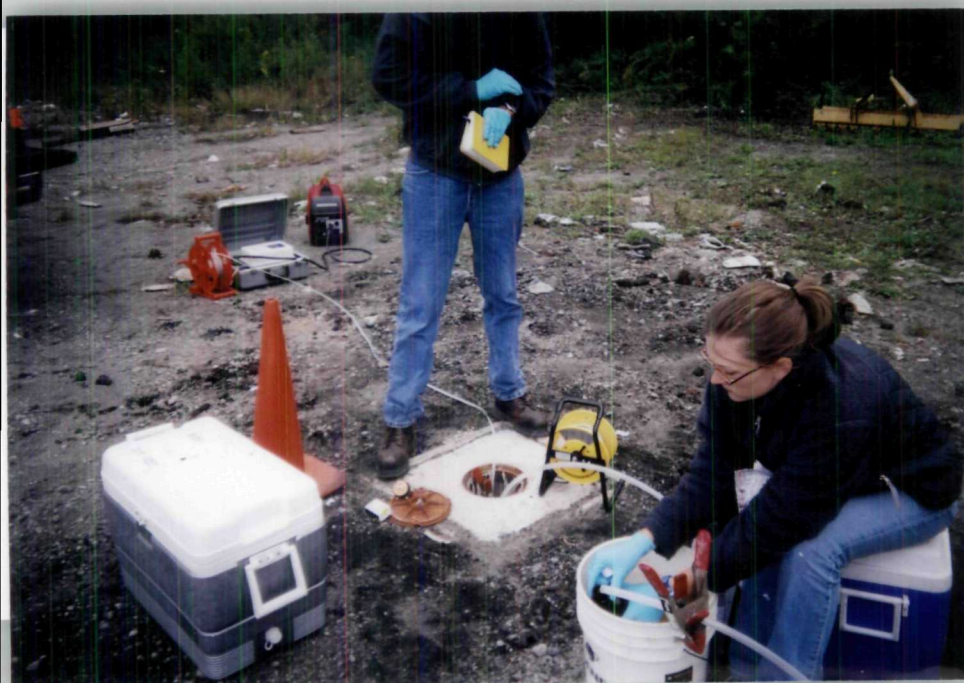
Site: American Chemical Service, Inc.
 Proj. #: 44728 AES [46526 RAC]
 Roll: 92 Photo #4
 Date: 9-19-06 Time: 1045
 Photographer: Larry Campbell
 Description: Photo facing southeast showing Leslie (MWH) collecting groundwater sample from MW58.

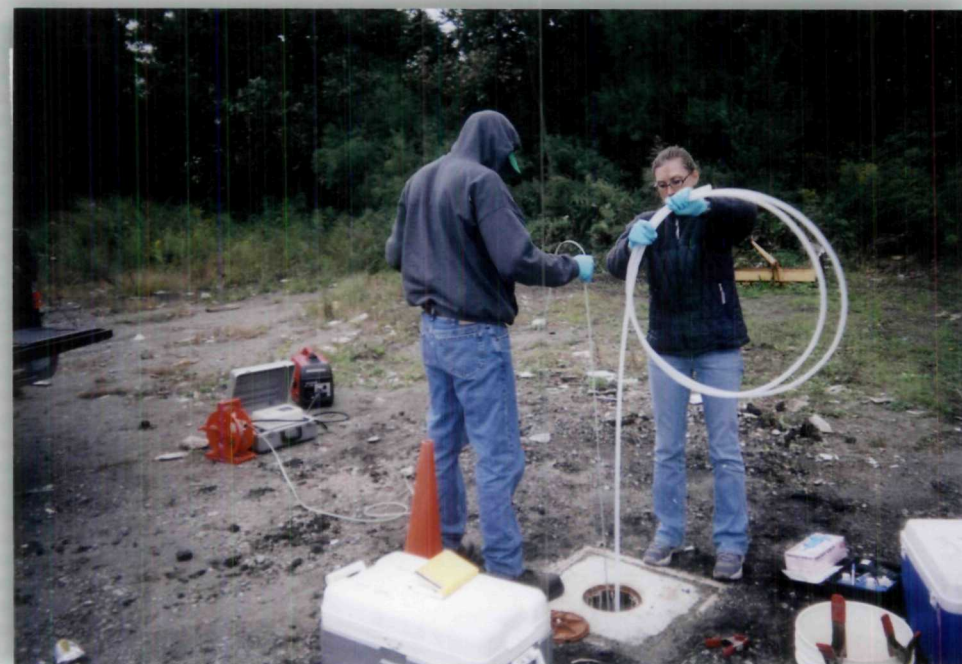
Site: American Chemical Service, Inc.
 Proj. #: 44728 AES [46526 RAC]
 Roll: 92 Photo #5
 Date: 9-19-06 Time: 1054
 Photographer: Larry Campbell
 Description: Photo facing south showing MWH sampling crew removing the sampling pump from MW58.

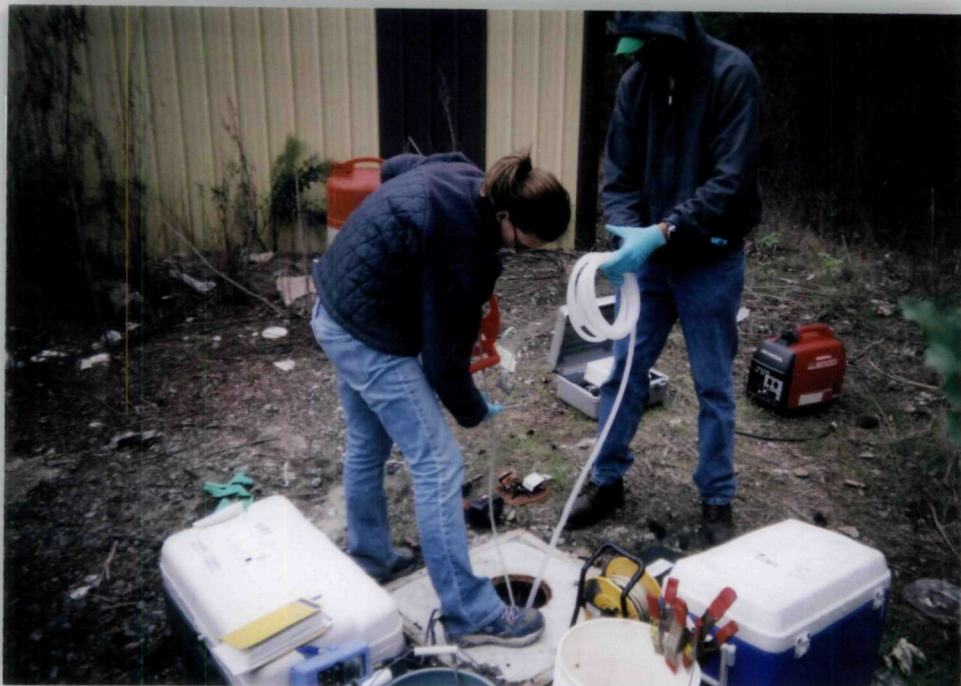
Site: American Chemical Service, Inc.
Proj. #: 44728 AES [46526 RAC]
Roll: 92 Photo #6
Date: 9-19-06 Time: 1123
Photographer: Larry Campbell
Description: Photo facing north showing MWH crew lowering pump and installing new tubing in MW59.

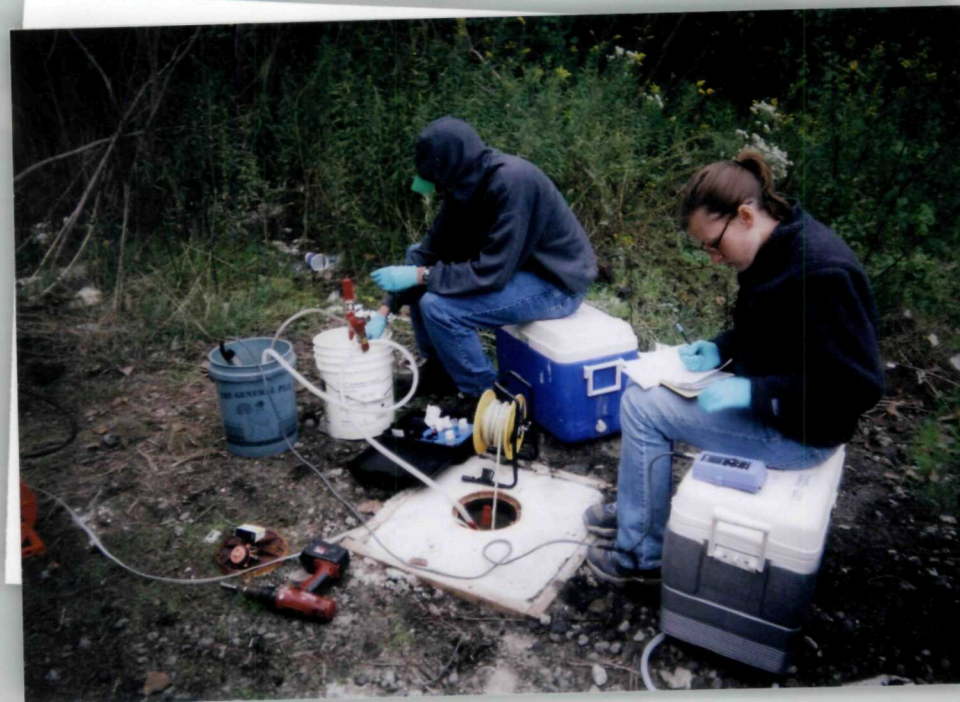
Site: American Chemical Service, Inc.
Proj. #: 44728 AES [46526 RAC]
Roll: 92 Photo #7
Date: 9-19-06 Time: 1140
Photographer: Larry Campbell
Description: Photo facing east showing MWH crew purging MW59 prior to sampling.

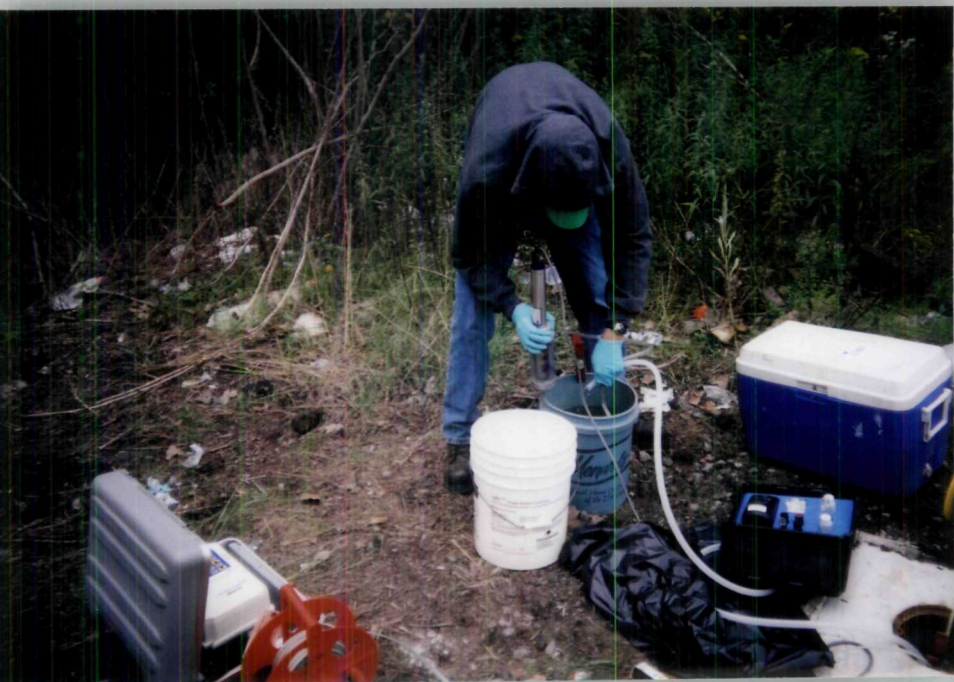
Site: American Chemical Service, Inc.
 Proj. #: 44728 AES [46526 RAC]
 Roll: 92 Photo #8
 Date: 9-19-06 Time: 1341

Photographer: Larry Campbell
 Description: Photo facing southeast showing MWH crew removing Horeba cell in preparation to sample groundwater. Took more than 2 hours to purge the well.

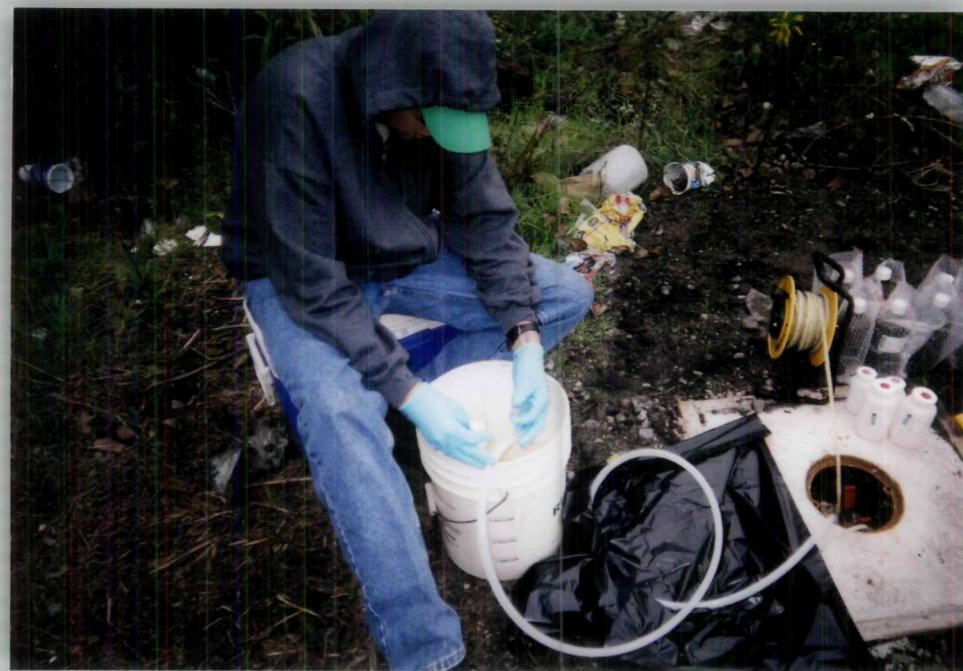
Site: American Chemical Service, Inc.
 Proj. #: 44728 AES [46526 RAC]
 Roll: 92 Photo #9
 Date: 9-19-06 Time: 1346
 Photographer: Larry Campbell
 Description: Photo facing southeast showing MWH crew collecting VOC sample from MW59.

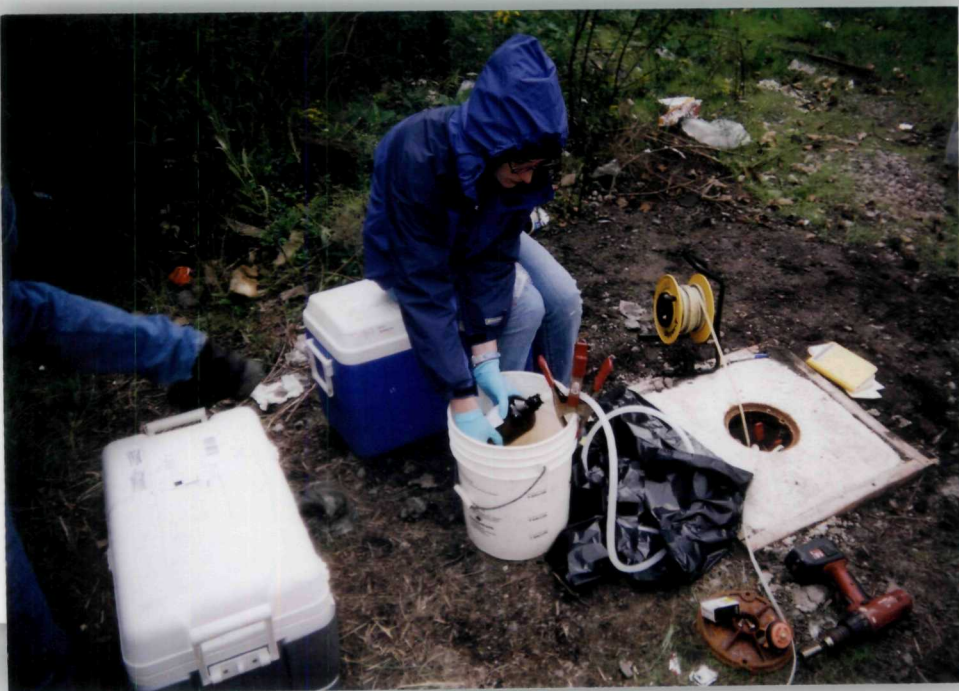
Site: American Chemical Service, Inc.
Proj. #: 44728 AES [46526 RAC]
Roll: 92 Photo #10
Date: 9-19-06 Time: 1401
Photographer: Larry Campbell
Description: Photo facing south showing MWH crew collecting last groundwater sample from MW59.

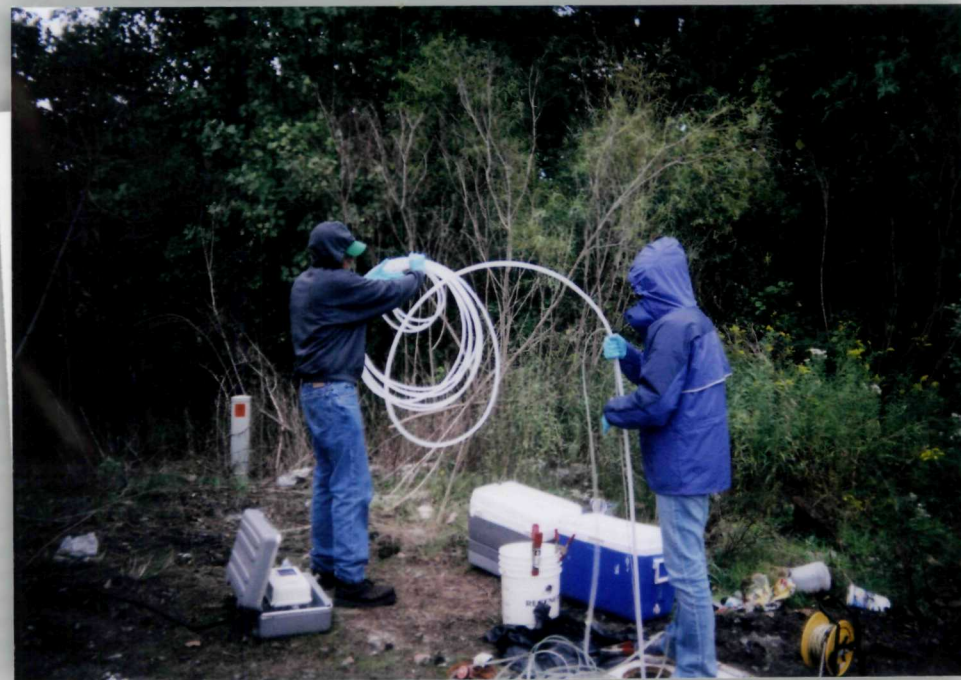
Site: American Chemical Service, Inc.
Proj. #: 44728 AES [46526 RAC]
Roll: 92 Photo #11
Date: 9-19-06 Time: 1405
Photographer: Larry Campbell
Description: Photo facing east showing MWH crew removing pump from MW59. Dedicated tubing will be reinserted into well.

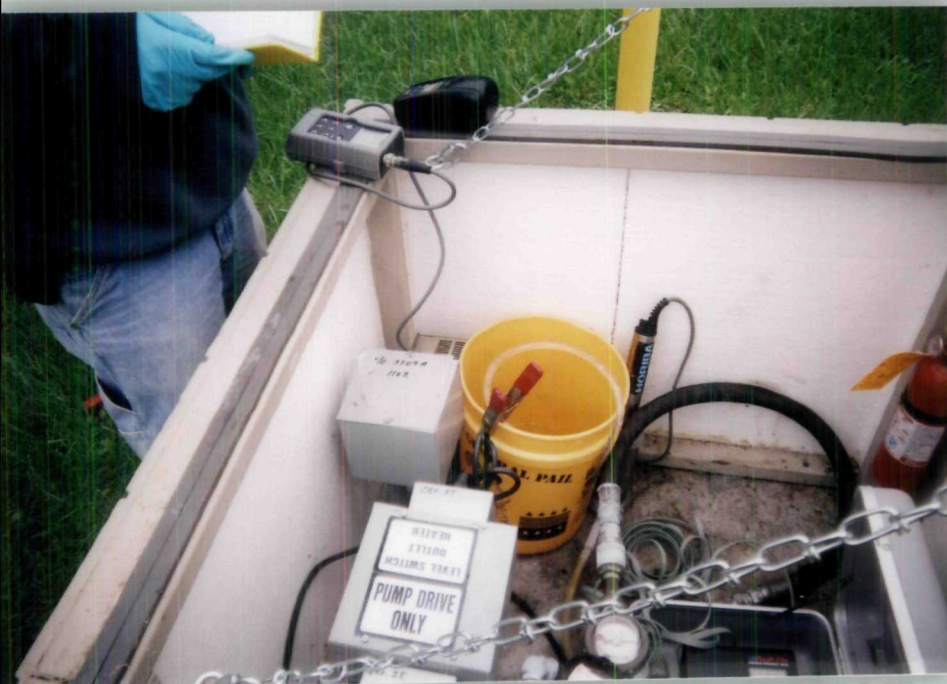
Site: American Chemical Service, Inc.
 Proj. #: 44728 AES [46526 RAC]
 Roll: 92 Photo #12
 Date: 9-19-06 Time: 1422
 Photographer: Larry Campbell
 Description: Photo facing down into pump shelter at MW56 showing well being purged.

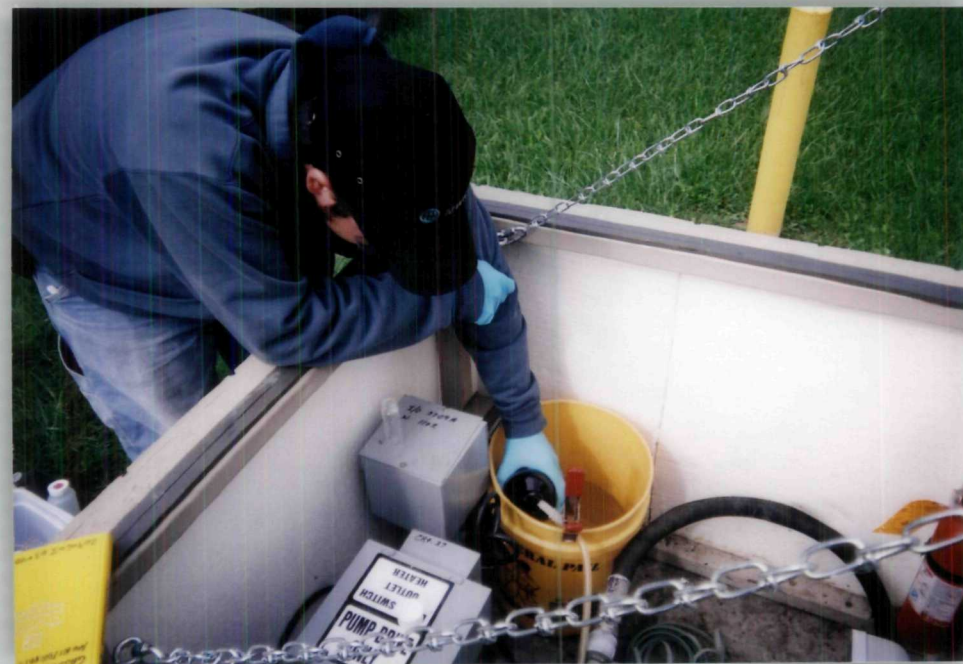
Site: American Chemical Service, Inc.
 Proj. #: 44728 AES [46526 RAC]
 Roll: 92 Photo #13
 Date: 9-19-06 Time: 1439
 Photographer: Larry Campbell
 Description: Photo facing down into MW56 pump shelter showing Justin collecting groundwater sample.

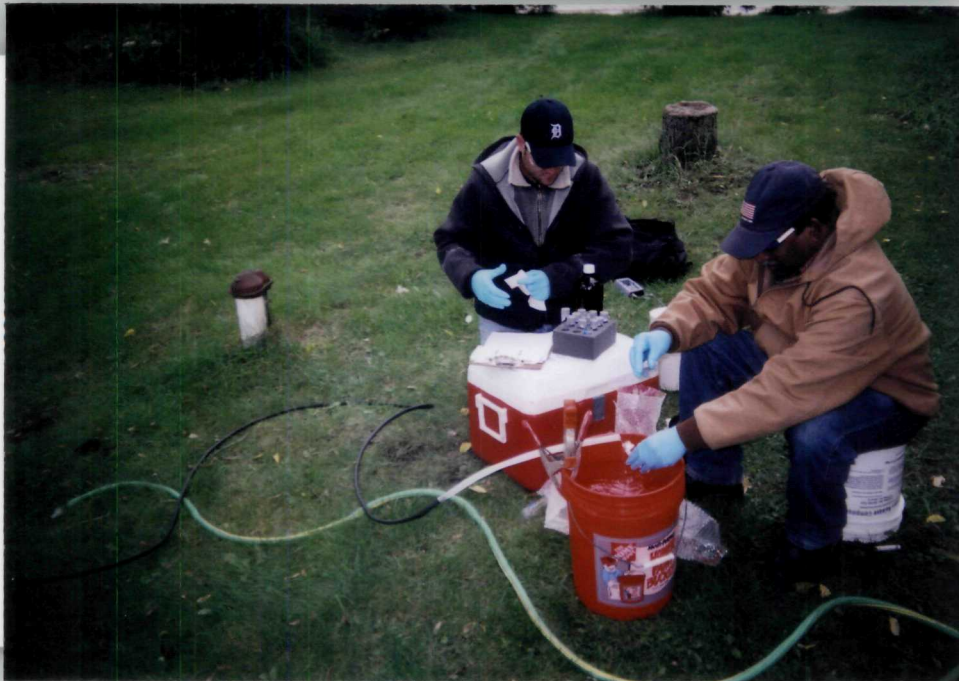
Site: American Chemical Service, Inc.
Proj. #: 44728 AES [46526 RAC]
Roll: 92 Photo #14
Date: 9-19-06 Time: 1450
Photographer: Larry Campbell
Description: Photo facing south showing Prabhakar Kasarabada (IDEM) (on right) assisting MWH crew in collecting VOC samples at residential well PW-C at 1029 Reder Road.

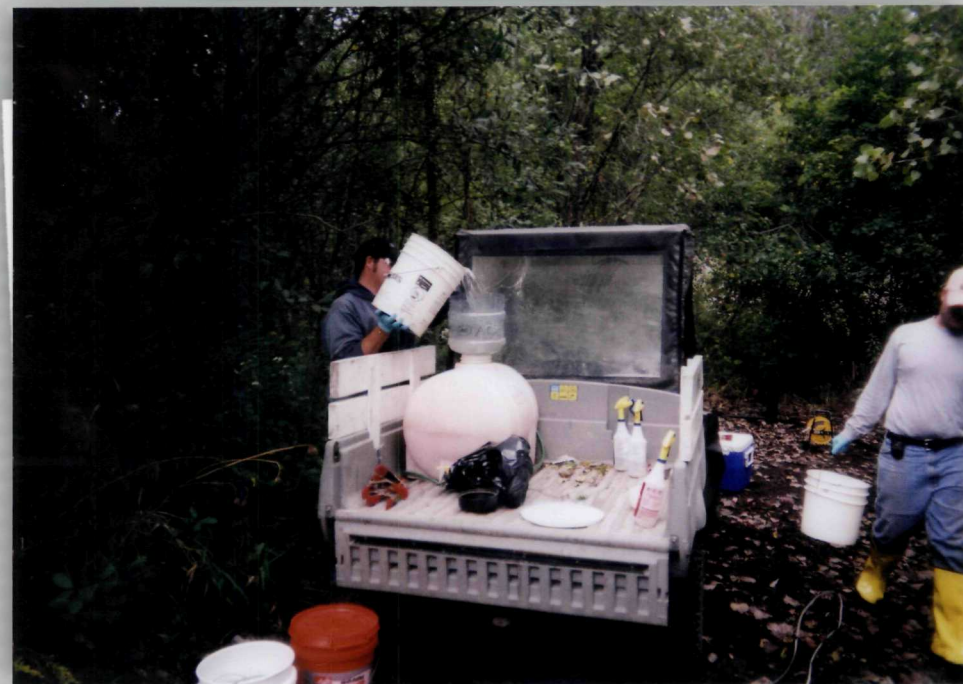
Site: American Chemical Service, Inc.
Proj. #: 44728 AES [46526 RAC]
Roll: 92 Photo #15
Date: 9-22-06 Time: 0930
Photographer: Larry Campbell
Description: Photo facing north showing Justin disposing of purge water into tank after sampling MW51. Purge water will be processed through the groundwater treatment plant. This is last well in semiannual sampling.

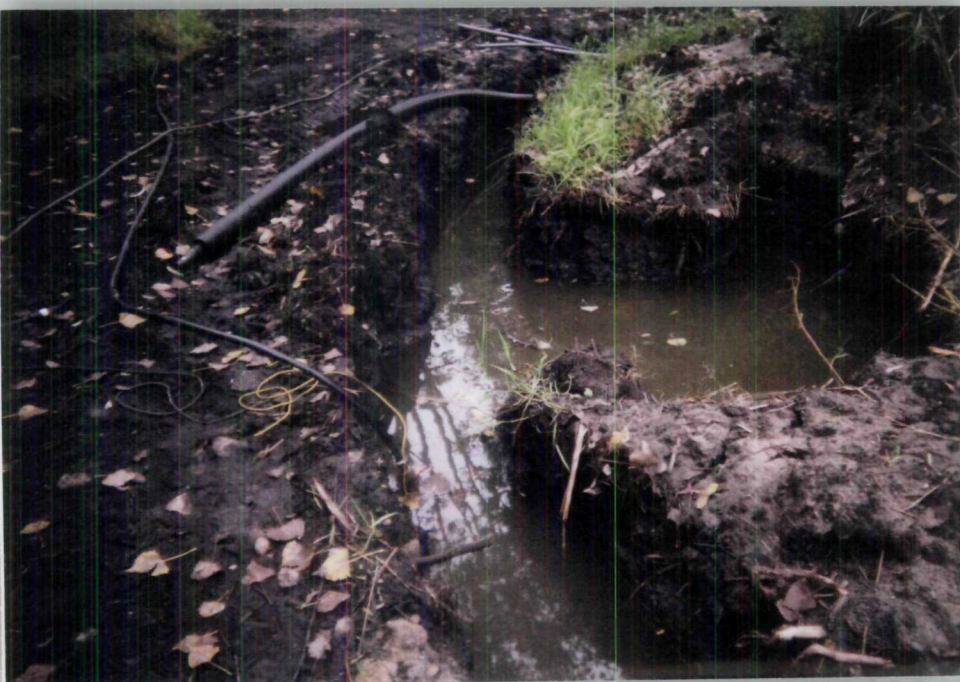
Site: American Chemical Service, Inc.
 Proj. #: 44728 AES [46526 RAC]
 Roll: 92 Photo #16
 Date: 9-22-06 Time: 1048
 Photographer: Larry Campbell
 Description: Photo facing east showing lower aquifer conveyance trench with sump pump being used to dewater the trench.

- MWH reported that it used a sump pump and trash pump to dewater the excavated trench on September 26 and successfully installed 2-inch-diameter double-walled HDPE conveyance piping and two 1-inch-diameter PVC electrical conduits to the end of the excavated trench.

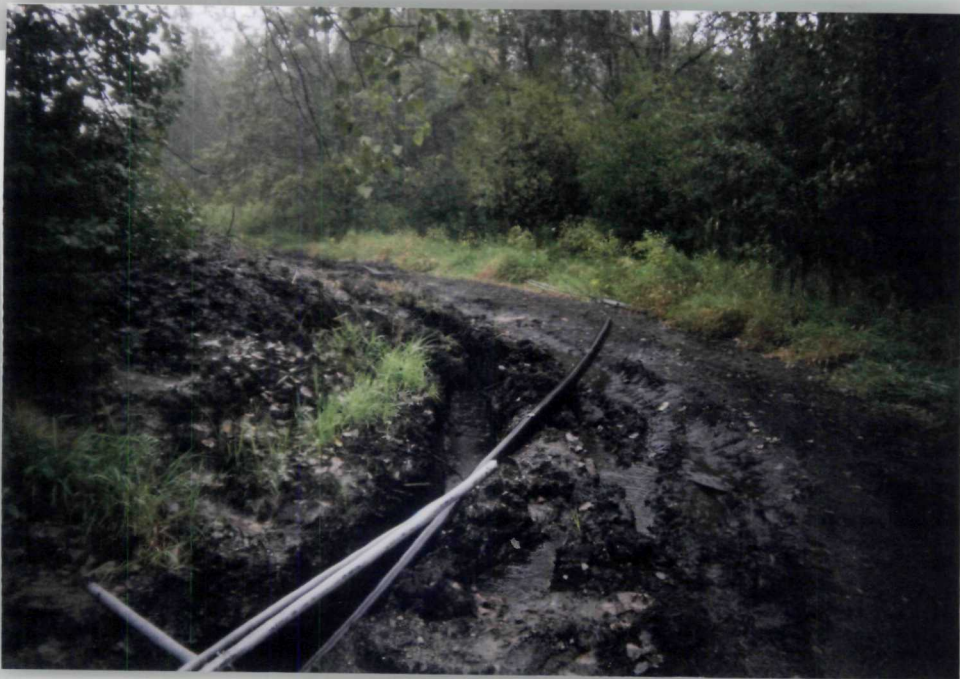
Site: American Chemical Service, Inc.
Proj. #: 44728 AES [46526 RAC]
Roll: 91 Photo #24
Date: 9-11-06 Time: 1047
Photographer: Larry Campbell
Description: Photo facing west showing new conveyance piping trench excavated from end of previous trench. Note black HDPE conveyance piping and white PVC electrical conduit.

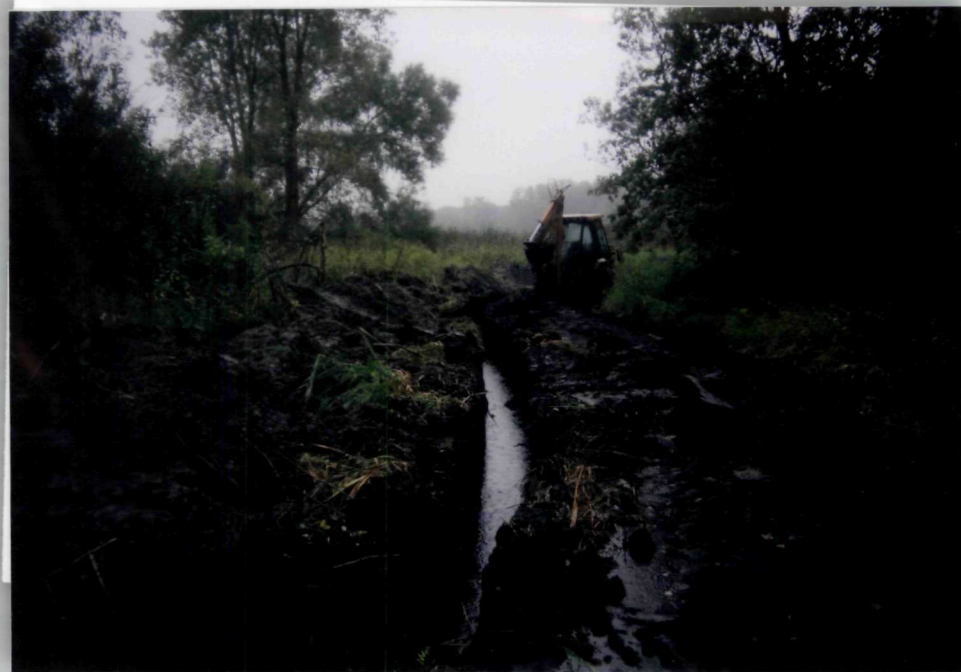
extraction wells near the northern property line. Austgen excavated to within about 100 feet of the lower aquifer wells but could not continue because of soft soil conditions.

Site: American Chemical Service, Inc.
Proj. #: 44728 AES [46526 RAC]
Roll: 91 Photo #25
Date: 9-11-06 Time: 1050
Photographer: Larry Campbell
Description: Photo facing southwest showing excavated trench and backhoe stuck in mud. Note water in trench.

- MWH reported that it will evaluate additional options to complete installation of the lower aquifer conveyance piping, including deferring the installation until site conditions (e.g., dry or frozen) will support construction equipment.

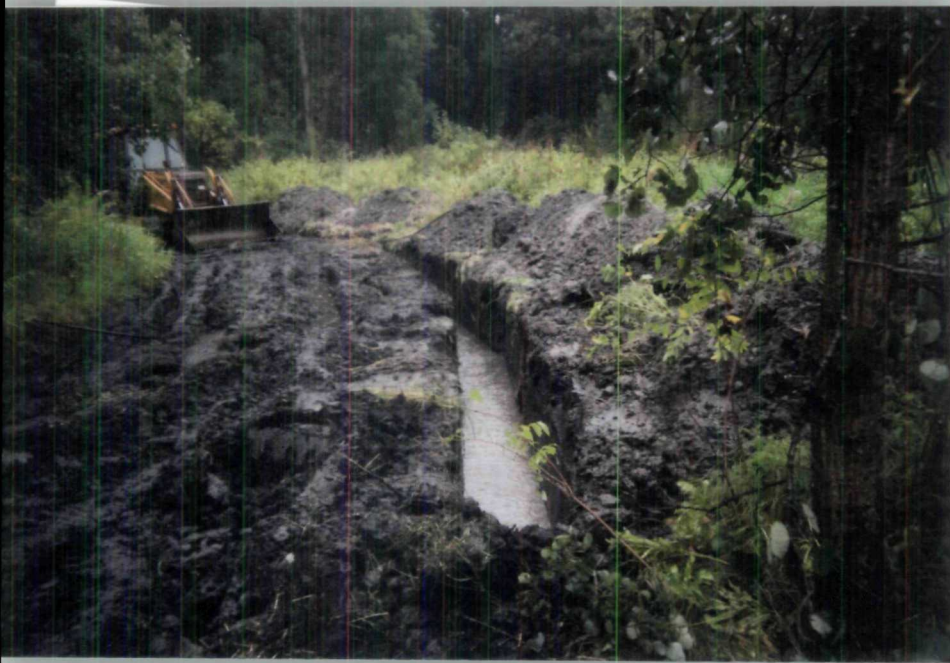
Site: American Chemical Service, Inc.
 Proj. #: 44728 AES [46526 RAC]
 Roll: 91 Photo #26
 Date: 9-11-06 Time: 1055
 Photographer: Larry Campbell
 Description: Photo facing east at current end of
 excavated trench approximately 100' south of MW53.

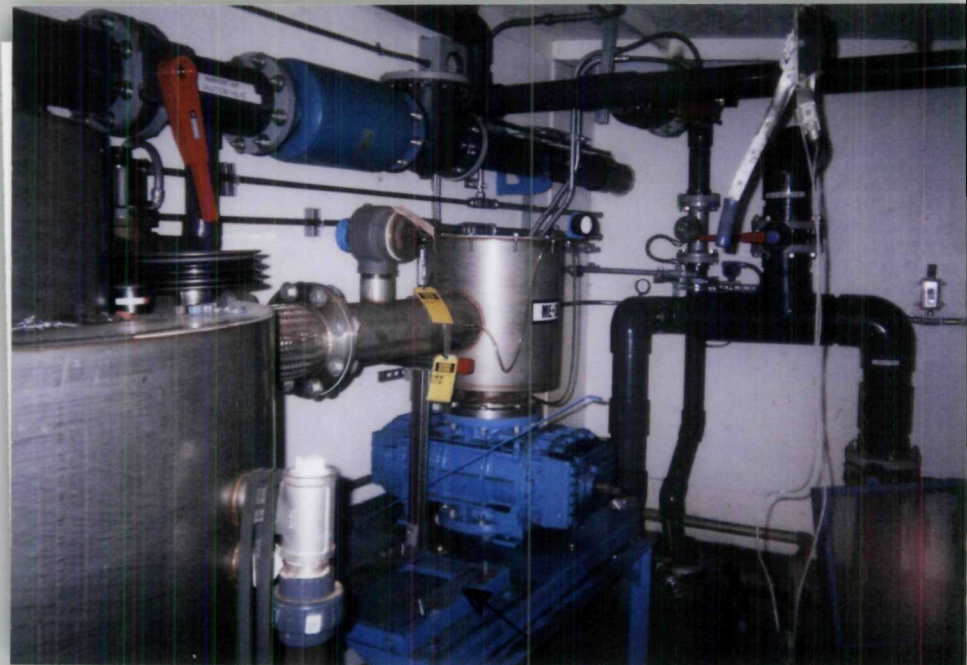
Site: American Chemical Service, Inc.
 Proj. #: 44728 AES [46526 RAC]
 Roll: 92 Photo #1
 Date: 9-11-06 Time: 1120
 Photographer: Larry Campbell
 Description: Photo facing west inside the SBPA ISVE
 blower shed showing location of non-working blower
 motor.
